**Capital Improvements and Asset Management Plan
Buzzards Bay Water District
Buzzards Bay, Massachusetts**

June 2021

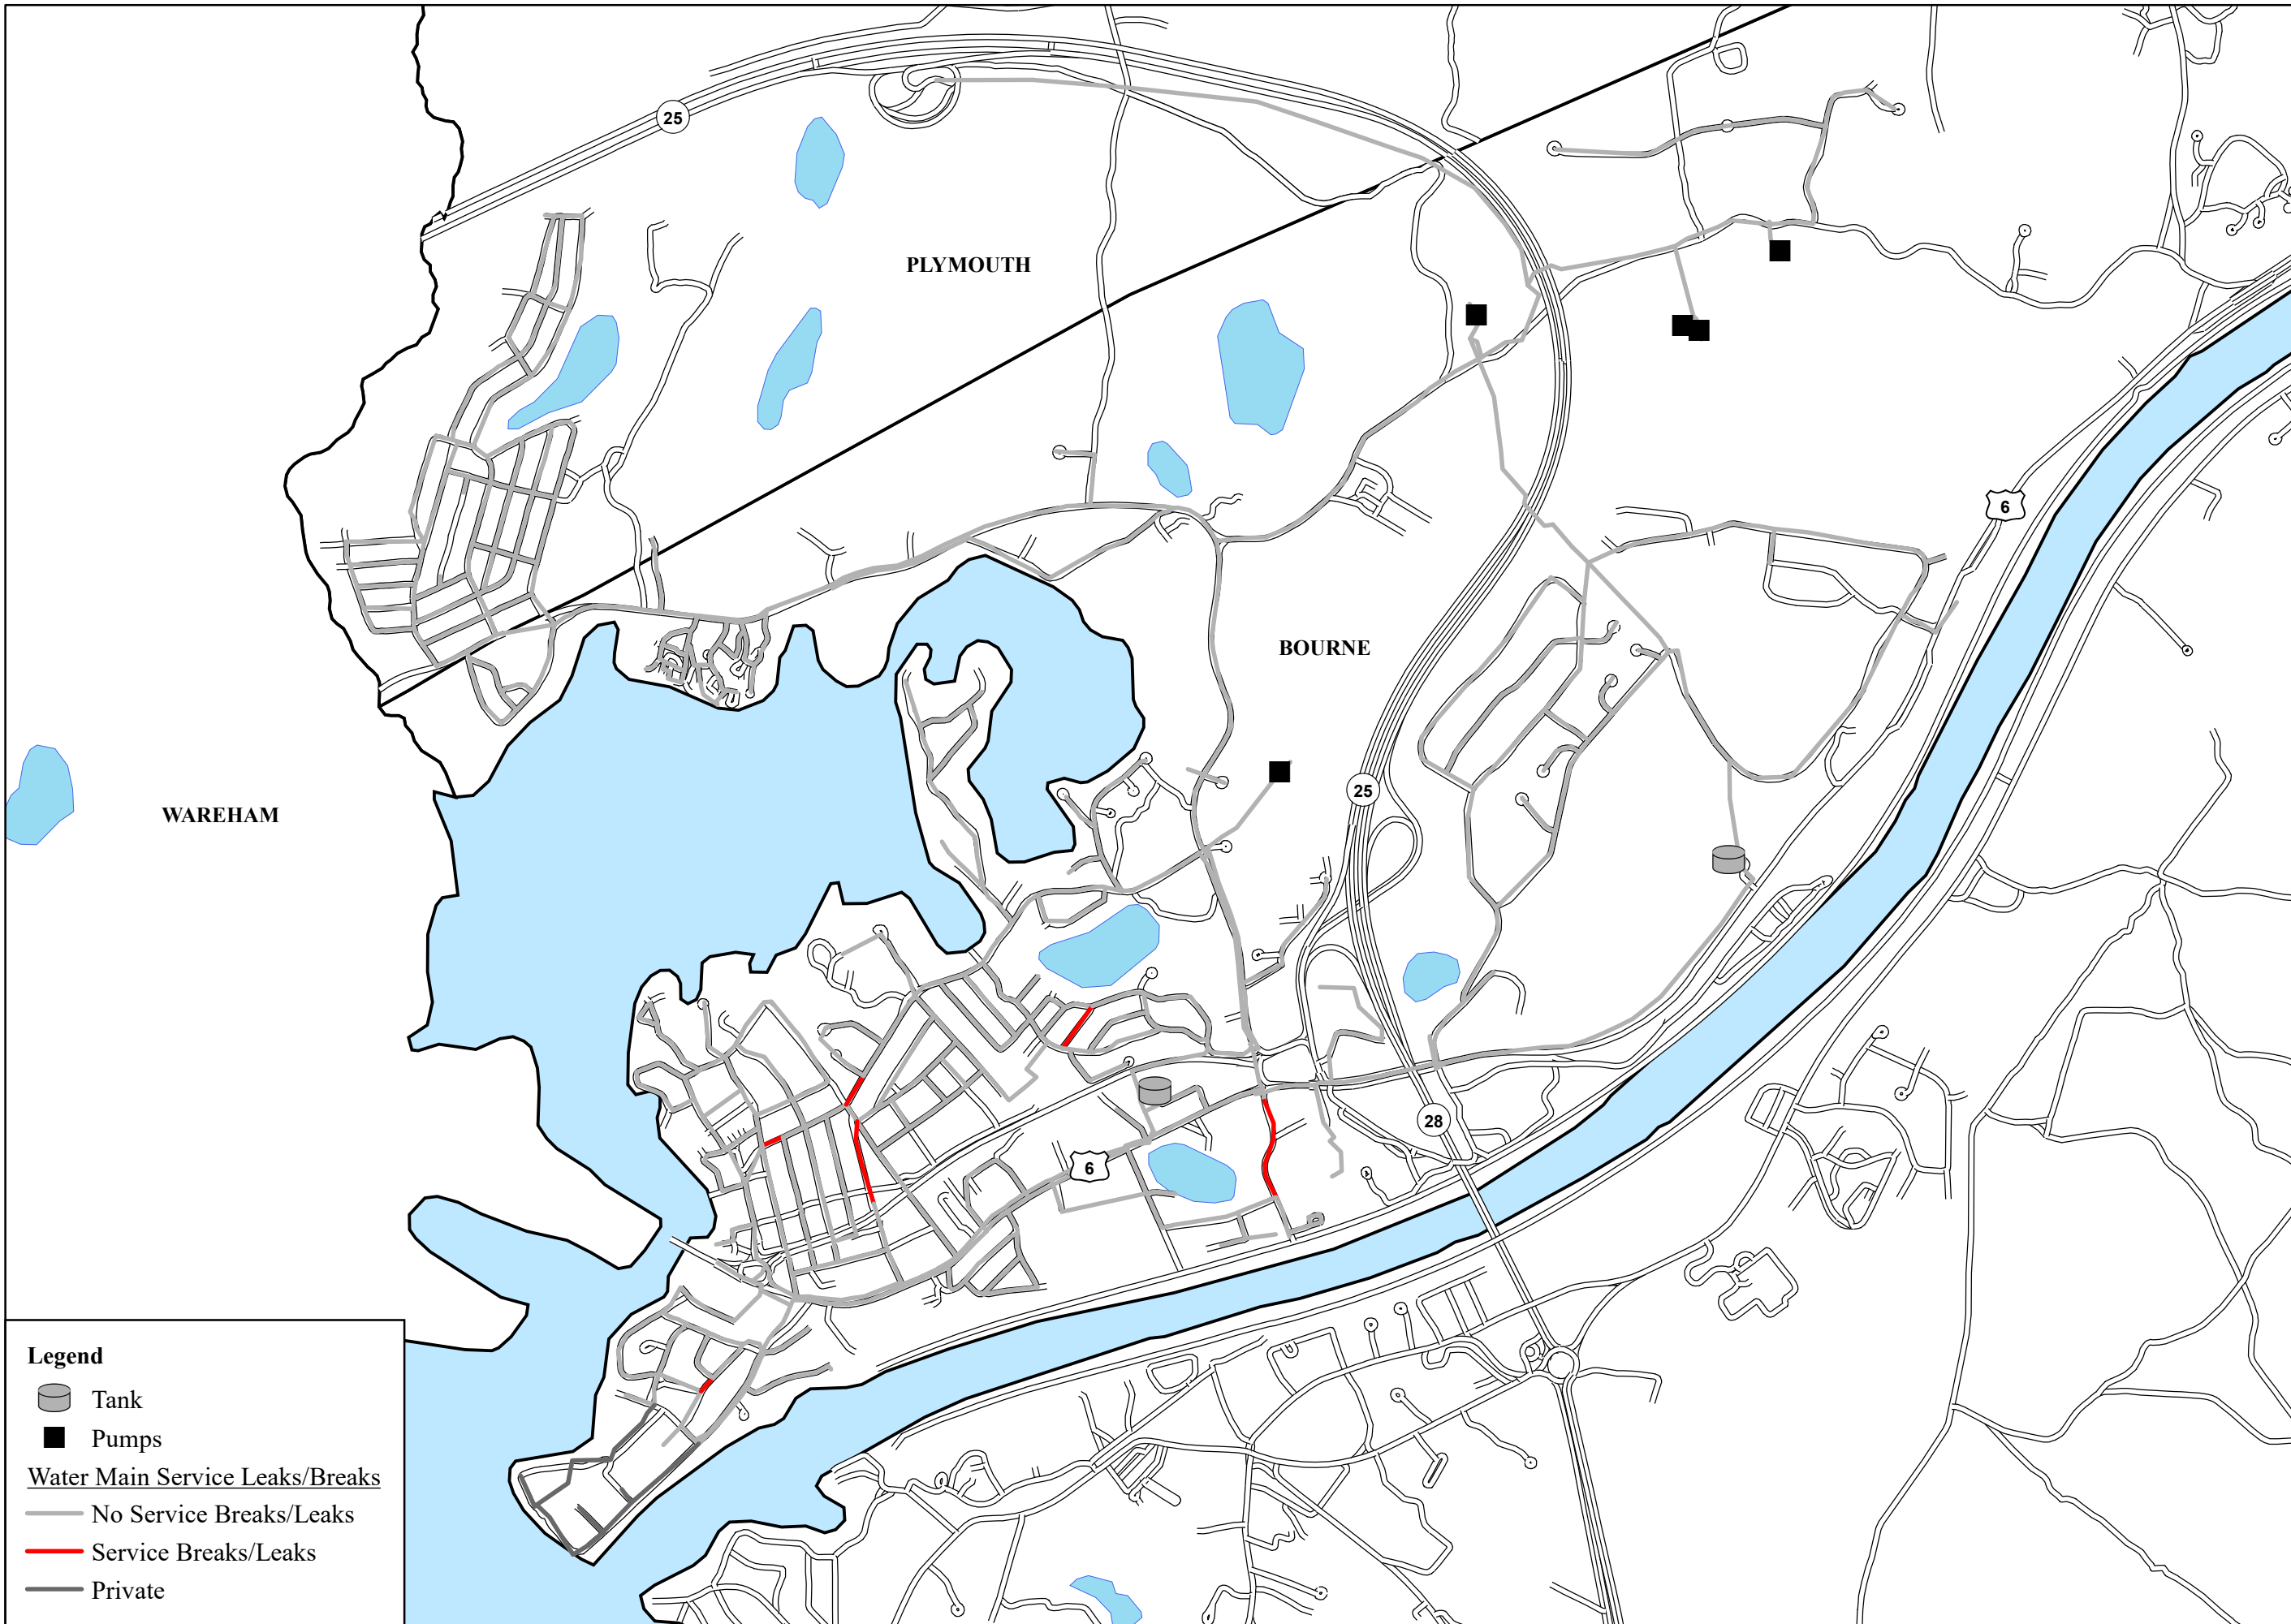
Service Breaks/Leaks
Capital Improvements and Asset Management Plan
Buzzards Bay Water District

The Buzzards Bay water system has multiple locations with service leaks that historically have been caused by a number of reasons such as problems with the pipe itself or the associated fittings. The records provided also included a large number of locations with broken curb stops that were replaced. These locations were not included in the pipe break analysis as these instances could not be confirmed to be associated with a pipe failure. Locations of service leaks were provided by the BBWD. The areas identified as having experienced a history of services leaks have been given a rating of 100 while areas with no known history of leaks received a rating of zero. These areas are shown in Figure No. 6-6.

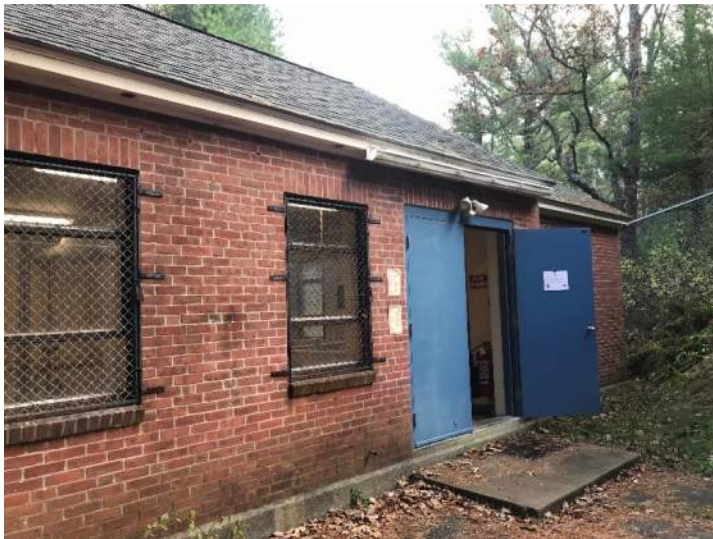
7.2.1 Pump Station No. 1

Pump Station No. 1 (4036001-01G) is a gravel packed well located off Dry Cedar Swamp Road, installed in 1981. The associated well has a depth of approximately 38 feet with an 8 foot screen. The pump station for Well No. 1 consists of two buildings, Building A and Building B. Building A houses the main pumping equipment and Building B houses the electrical, instrumentation, and chemical feed equipment for the well. The well and buildings are in good to fair condition.

The chemical feed systems in both buildings have been partially upgraded, with several major electrical components being replaced in 1992 in Building A and the chemical feed equipment being replaced in 2020. As the chemical feed equipment is less than one year old, it is considered to be in excellent condition. The electrical equipment is almost thirty years old and as such is nearing the end of its useful life. The BBWD should begin preparing to replace this equipment. A new propane tank was also installed in 2020. The buildings themselves are

both older brick buildings. Neither is in poor condition, but as Building A was constructed in 1937 it has reached the end of its useful life. Extra maintenance costs for this building was included in the PLA and the BBWD should be prepared for increased maintenance costs to both buildings as they continue to age.

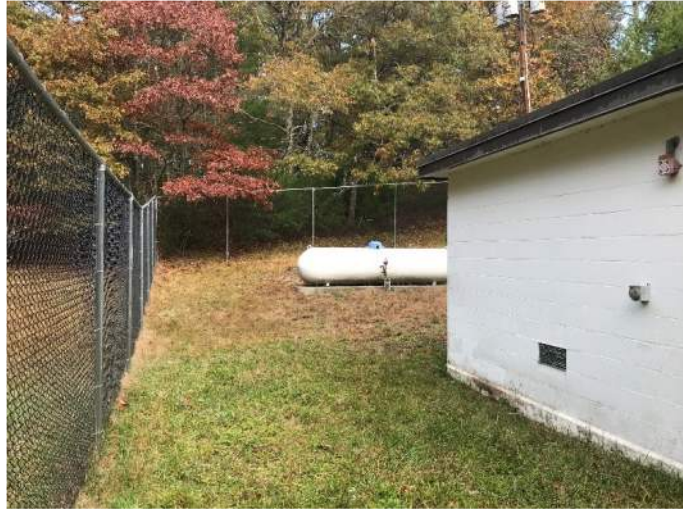
7.2.2 Pump Station No. 2

Pump Station No. 2 (4036001-02G) is a gravel packed well located on Kettle Lane off Head of the Bay Road, installed in 1966. The associated well has a depth of approximately 42.75 feet with a 10 foot screen. The pumping station building is in good condition. The equipment in this station has been upgraded over several years, with new chemical feed equipment being installed in 1993. The potassium hydroxide system is in fair to poor condition and should be considered for replacement. The well pump was also installed in 1992 and is approaching the end

of its useful life and it is recommended that the BBWD begin preparing for its replacement. The building itself is in good condition, but the interior floor is in fair condition and could benefit from resurfacing. The electrical equipment was installed in 1992 and as such is nearing the end of its expected useful life. The BBWD should begin preparing for its replacement.

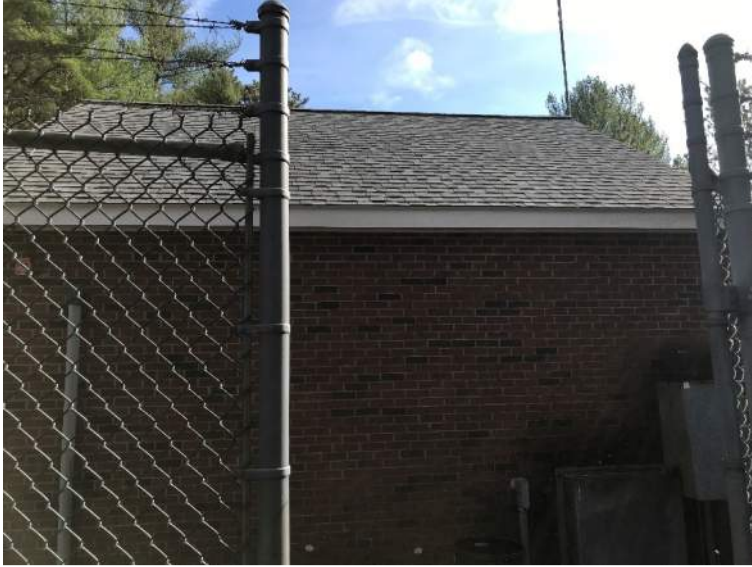
7.2.4 Pump Station No. 4

Pump Station No. 4 (4036001-04G) is a gravel packed well located at Bournedale Road, installed in 1988. The associated well has a depth of approximately 64 feet with a 10 foot screen. The pumping station is in good condition. The equipment in this station has been replaced in part between 1993 and 2018 with various upgrades to the electrical, SCADA, and chemical feed equipment. The well pump motor was recently replaced but the well pump is reaching the end of its estimated useful life. The BBWD should begin to prepare for its replacement along with the electrical

equipment which is nearing the end of its expected useful life.

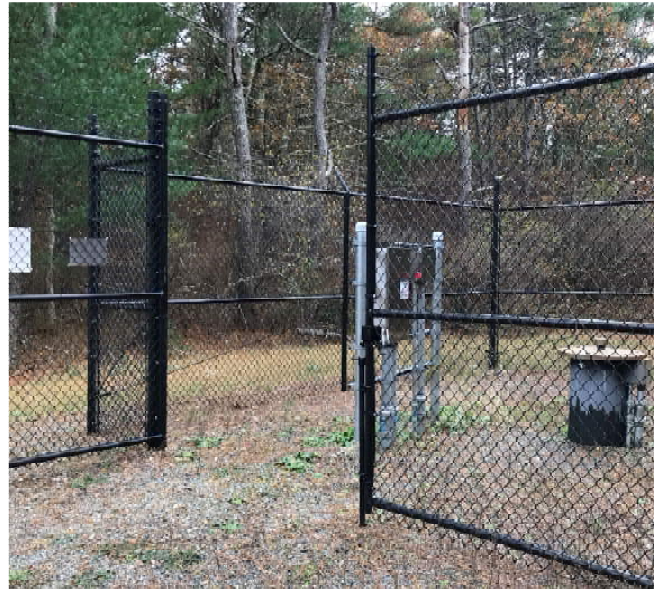
7.2.5 Well No. 5

Well No. 5 (4036001-05G) is a 24”x18” gravel packed well located off Bournedale Road adjacent to Pump Station No. 3. The well was installed in 2017 to a depth of approximately 70 feet with a 15 foot screen. The well is in good condition. Raw water from Well No. 5 is treated with water from Pump Station No. 3 at the Chemical Injection Facility. This well is the BBWD’s newest source and as such is not a concern for maintenance or replacement. The well is not housed in a building but is surrounded by a chain link fence with the electrical equipment mounted on posts.

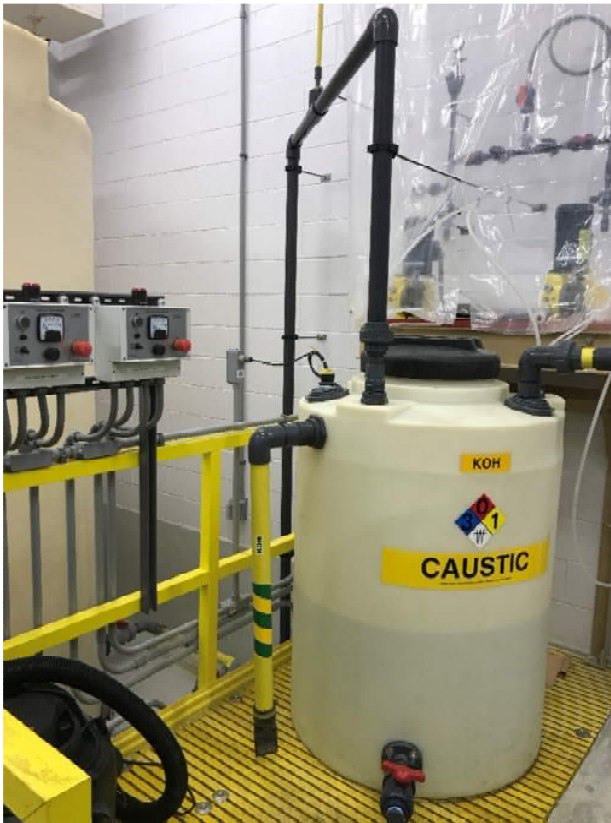
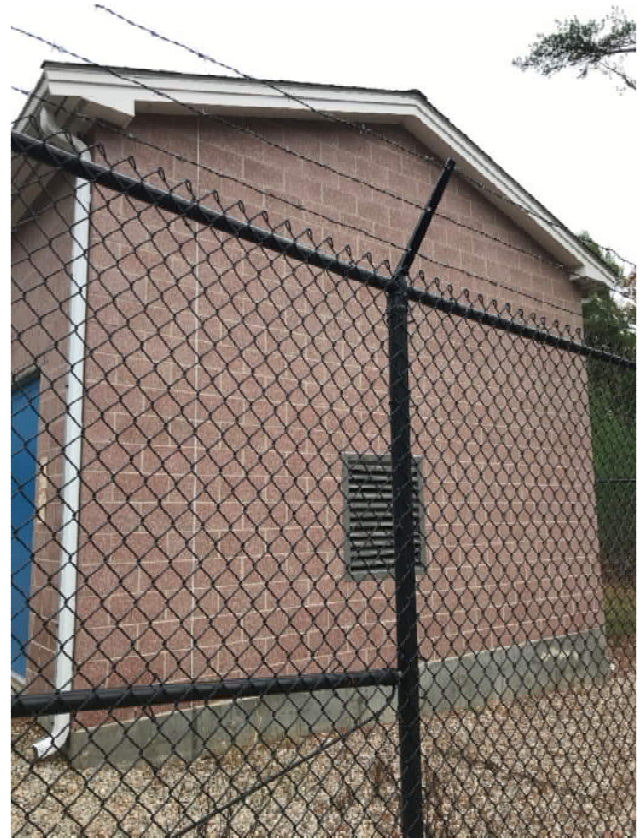
7.3.1 Chemical Injection Facility

The Chemical Injection Facility (4018000-05T) is a water treatment facility located on Bournedale Road. Raw water from Pump Station No. 3 and Well No. 5 is treated with potassium hydroxide (KOH) for pH adjustment and sodium hypochlorite (NaOCl) for disinfection. Equipment at this facility includes chemical feed equipment, instrumentation and controls, and electrical systems. The Chemical Injection Facility was constructed in 2018 and as the building and all equipment are

only three years old, it is in good condition. The BBWD should continue to monitor the facility and its equipment in order to keep everything in good condition with regular maintenance.

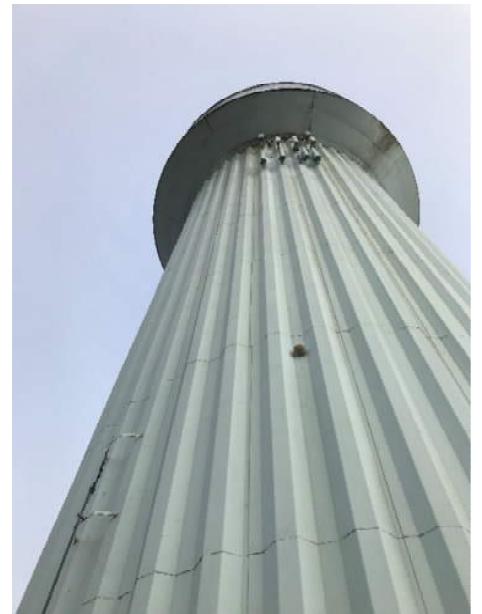
7.4.1 Hydropillar

The Hydropillar Water Storage Tank is a 1.0 mg steel elevated storage tank located off Wagner Way. The 40 foot tall tank has an overflow elevation of 215 feet and is on top of a 125 foot tall pedestal. The tank was constructed in 2001 and is in good condition. New SCADA and exterior lighting were installed at the site in 2017 and are in good condition. This tank should be inspected at least every five years.

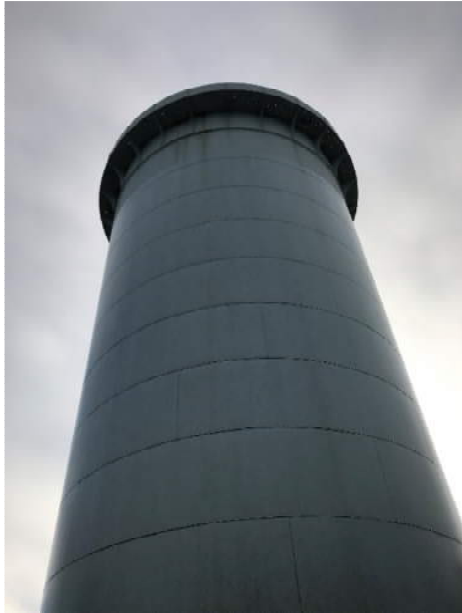
7.4.2 Standpipe

The Standpipe is a 1.0 mg steel standpipe located off State Highway 6. The tank has an overflow elevation of 215 feet, an inside diameter of 46 feet, and a total height of 85 feet. The tank was constructed in 1972 and was fully rehabilitated in 2005. The tank was then repainted in 2014. The Standpipe was most recently inspected in 2020 by Haley Ward and was found to be in good condition with no major concerns either on the interior or exterior of the tank. The report recommended that spot rehab to the exterior coating be performed on the tank.
